**BROOKS CREEK
DIAGNOSTIC STUDY
Jay County, Indiana**

March 22, 2002

BROOKS CREEK WATERSHED DIAGNOSTIC STUDY EXECUTIVE SUMMARY

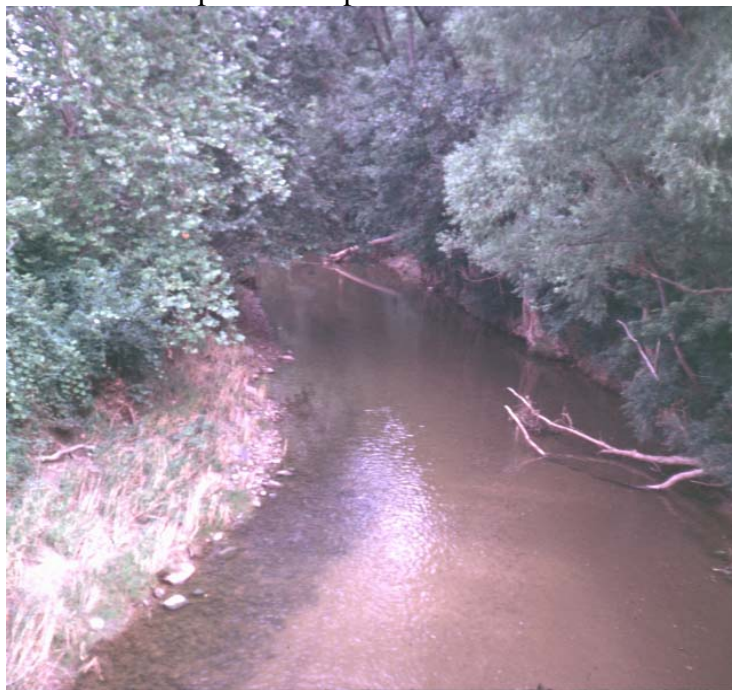
Reference Site – Eightmile Creek. The substrate type at this site was 90% sand. Moderate bank erosion was present. The immediate streamside was unvegetated, but higher along the banks the primary vegetation was trees (Figure 33). The banks were steeply sloping with an average height of 16.5 ft (5 m). The Reference Site scored 62.5 of 100 total possible points on the Qualitative Habitat Evaluation Index (QHEI). The QHEI pool score was 4 of 12 and the riffle score was 4 of 8, indicating that pool-riffle development was poor.

FIGURE 33. Reference site sampling location on Eightmile Creek.

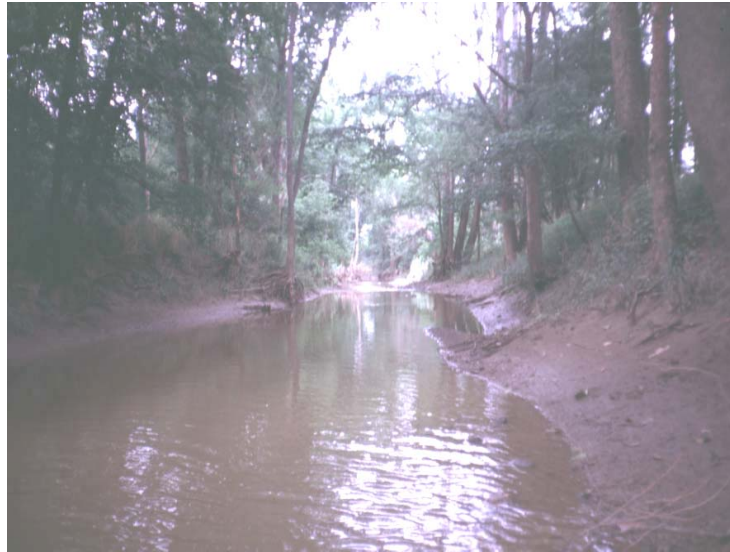
and woody debris provided in-stream habitat (Figure 34). Site 1 scored 57 of 100 total possible QHEI points.

FIGURE 34. Site 1 sampling location on Brooks Creek near its mouth.

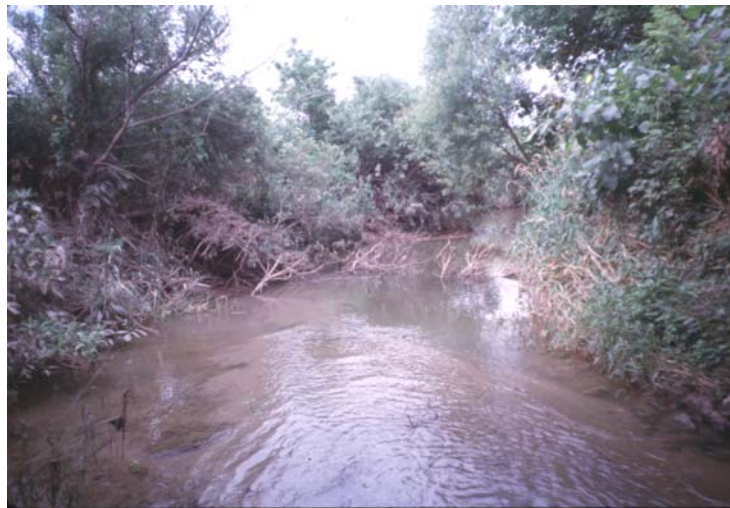
Site 2 – Mud Creek. The substrate type at this site was 30% sand, 30% silt, and 30% clay. The average height of the banks was 6.5 ft (2 m). There was little or no visible bank erosion. Banks were vegetated predominately by trees and shrubs (Figure 35). Overhanging vegetation, logs/woody debris, and shallows provided additional in-stream habitat. Site 2 scored 27 of 100 total possible points on the QHEI. The QHEI cover score was only 6 of 20, indicating that in-stream cover was nearly absent. The QHEI substrate score of only 5 of 20, indicates that the substrate was of poor quality. Pool-riffle development was absent with QHEI pool and riffle scores of 0.

FIGURE 35. Site 2 sampling location on Mud Creek.

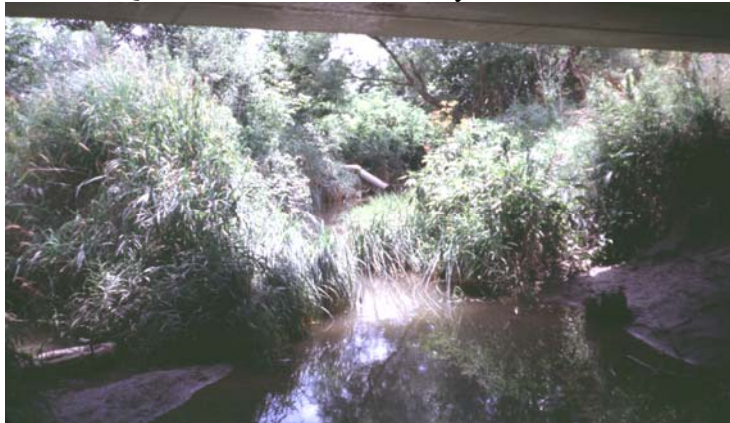
in-stream habitat. Site 3 scored 38 of 100 total possible points on the QHEI. Because in-stream cover was nearly absent, the QHEI cover score was only 3 of 20.

FIGURE 36. Site 3 sampling location on Mud Creek.

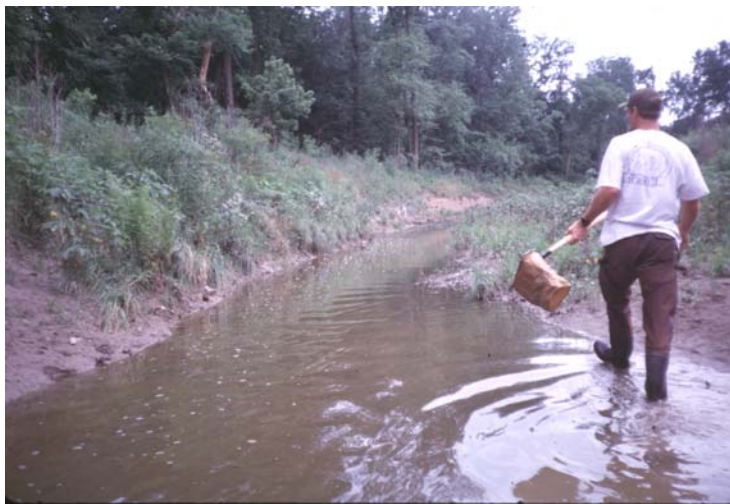
Site 4 – Brooks Creek. The substrate type at this site was 80% silt, 10% sand, and 10% clay. Brooks Creek was unconfined in this reach. Silt deposition had formed bars creating a “braided” stream channel. Upper banks were stabilized by trees and woody vegetation and had an average height of 6.5 ft (2 m). There was little or no bank erosion. Banks were vegetated predominately by herbaceous species (Figure 37). Canopy renovation/removal has eliminated riparian zones in the immediate vicinity. Remnant logs/woody debris provided limited in-stream cover. Site 2 scored 28.5 of 100 total possible points on the QHEI. The QHEI cover score was only 2 of 20, which indicates that in-stream cover was nearly absent. Pool and riffle scores of 0 indicate the absence of pool-riffle habitat.

FIGURE 37. Site 4 sampling location on Brooks Creek.

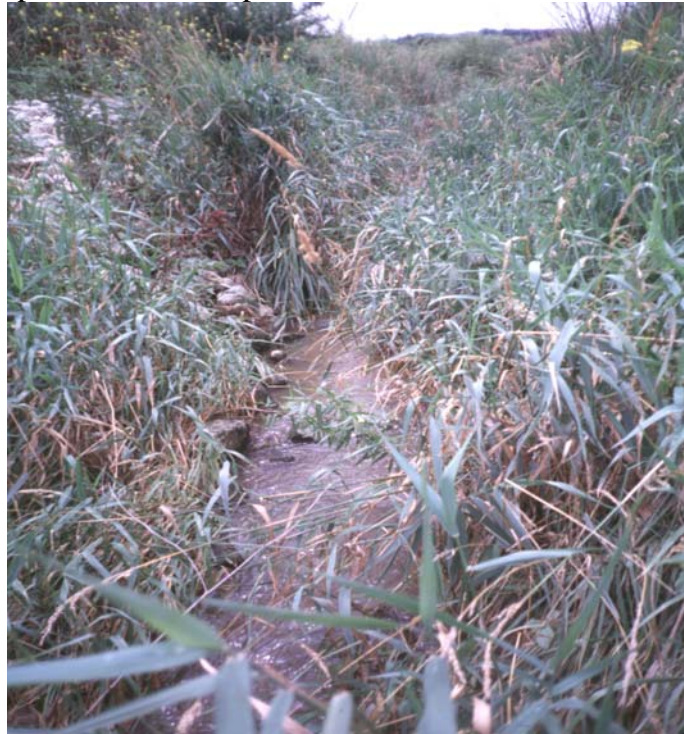
nearly absent. The QHEI substrate score was only 2 of 20, which indicates that the substrate was of poor quality. Little pool-riffle development was evident.

FIGURE 38. Site 5 sampling location on Harris Creek.

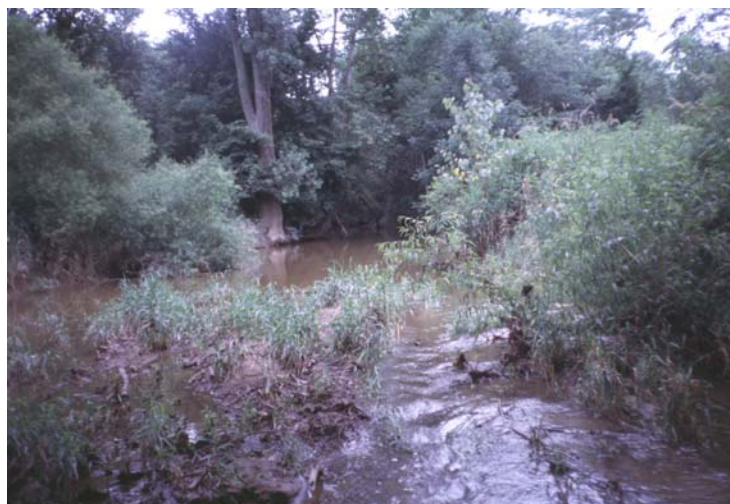
FIGURE 39. Site 6 sampling location on Brooks Creek.

Site 6 – Brooks Creek. The substrate type at this site was 90% sand and was extensively embedded. The average height of the banks was 6.5 ft (2 m). There was little or no bank erosion. Banks were vegetated predominately by herbaceous and woody vegetation (39). Overhanging vegetation, aquatic macrophytes, woody debris, and shallows provided in-stream habitat. Site 6 scored 33 of 100 total possible points on the QHEI. Pool-riffle development was absent.

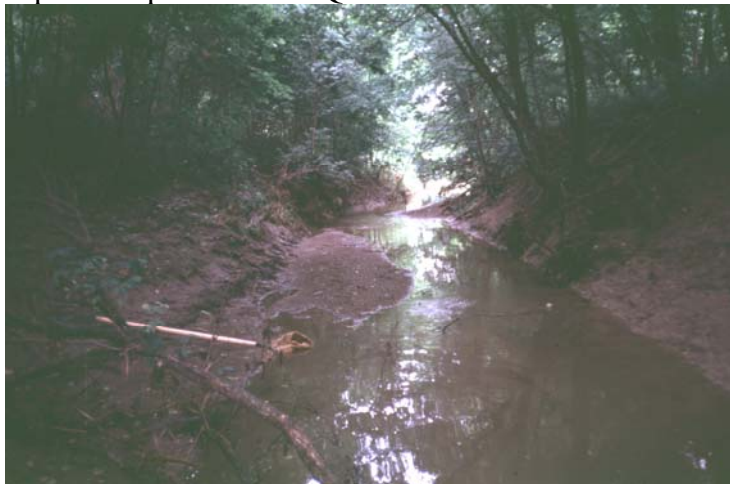
FIGURE 40. Site 7 sampling location on Smith-Hartman Ditch.

Site 7 – Smith-Hartman Ditch. The substrate type at this site was 90% sand. The average height of the banks was 5 ft (1.5 m). There was little or no bank erosion. Banks were not vegetated in the immediate vicinity of the streamside, but upper banks were vegetated predominately by trees (Figure 40). Overhanging vegetation and shallows provided minimal in-stream habitat. Site 7 scored 50 of 100 total possible points on the QHEI. Pool and riffle scores were also poor.

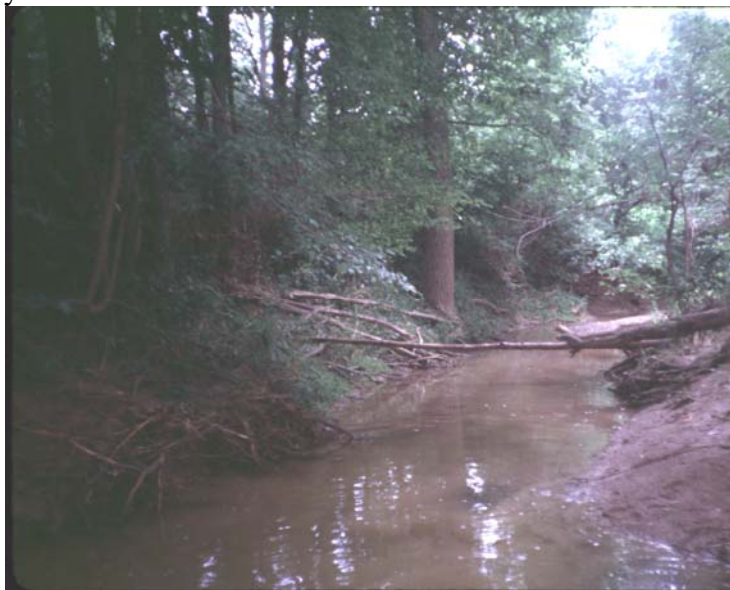
FIGURE 41. Site 8 sampling location on Phillips Run.

Site 8 – Phillips Run. The substrate type at this site was 90% sand. The average height of the banks was 1.5 ft (0.5 m). There was moderate bank erosion. Banks were vegetated predominately by trees (Figure 41). Overhanging vegetation, logs/woody debris, and shallows provided in-stream habitat. A moderately developed pool-riffle sequence provided additional habitat. Site 8 scored 61 of 100 total possible points on the QHEI. This was the highest QHEI score assigned to any stream in the Brooks Creek Watershed.

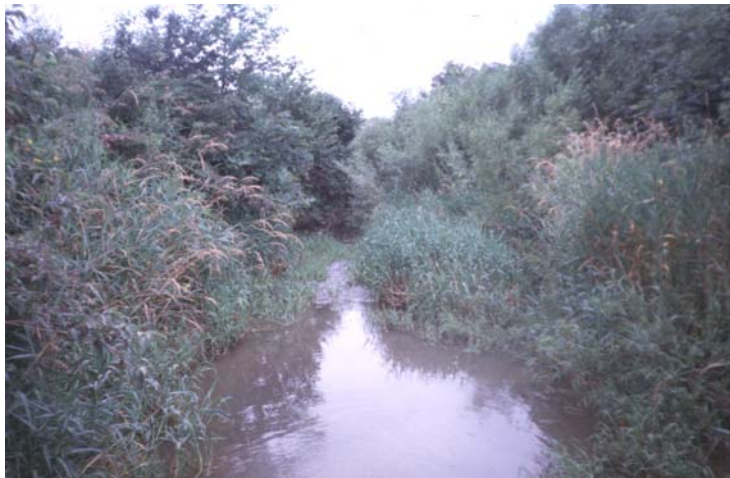
FIGURE 42. Site 9 sampling location on Brooks Creek.

Site 9 – Brooks Creek. The substrate type at this site was 90% sand. The average height of the banks was 8 ft (2.5 m). There was little or no bank erosion. Streamside vegetation consisted of

non-native pasture grasses and aquatic macrophytes; upper banks were vegetated predominately by shrubs and trees (Figure 42). Moderately developed pool-riffle sequences, aquatic macrophytes, and woody debris provide in-stream vegetation. Site 9 scored 39 of 100 total possible points on the QHEI. With a QHEI cover score of only 4 of 20, in-stream cover was nearly absent.

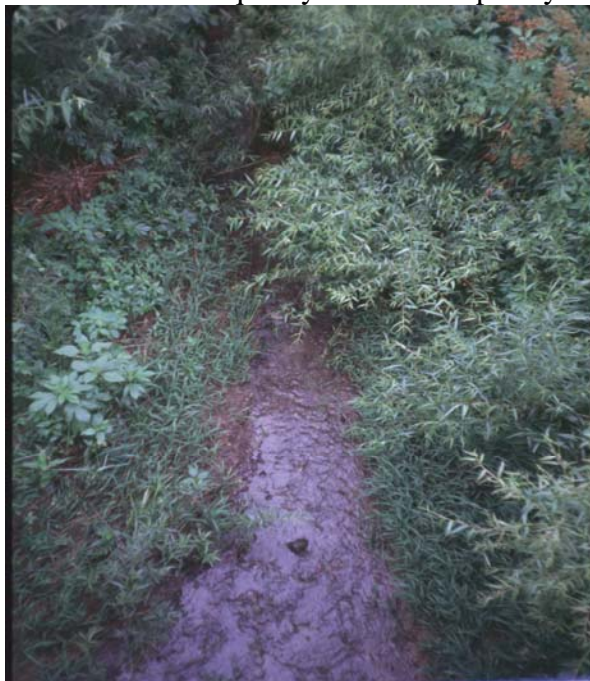
FIGURE 43. Site 10 sampling location on Brooks Creek.

Site 10 – Brooks Creek. The substrate type at this site was 50% sand, 30% gravel, and 20% silt. The average height of the banks was 8 ft (2.5 m). There was little or no bank erosion. Banks were vegetated predominately by shrubs and herbaceous species (Figure 43). Overhanging vegetation, aquatic macrophytes, and shallows provide in-stream habitat. Site 10 scored 31 of 100 total possible points on the QHEI. The QHEI cover score of only 6 of 20 indicates that in-stream cover was nearly absent. Substrate quality also scored poorly.
